INSTALLATION RESTORATION PROGRAM

Supplemental Site Investigation Report

February 1997

144TH FIGHTER WING
CALIFORNIA AIR NATIONAL GUARD
FRESNO AIR TERMINAL, FRESNO, CALIFORNIA

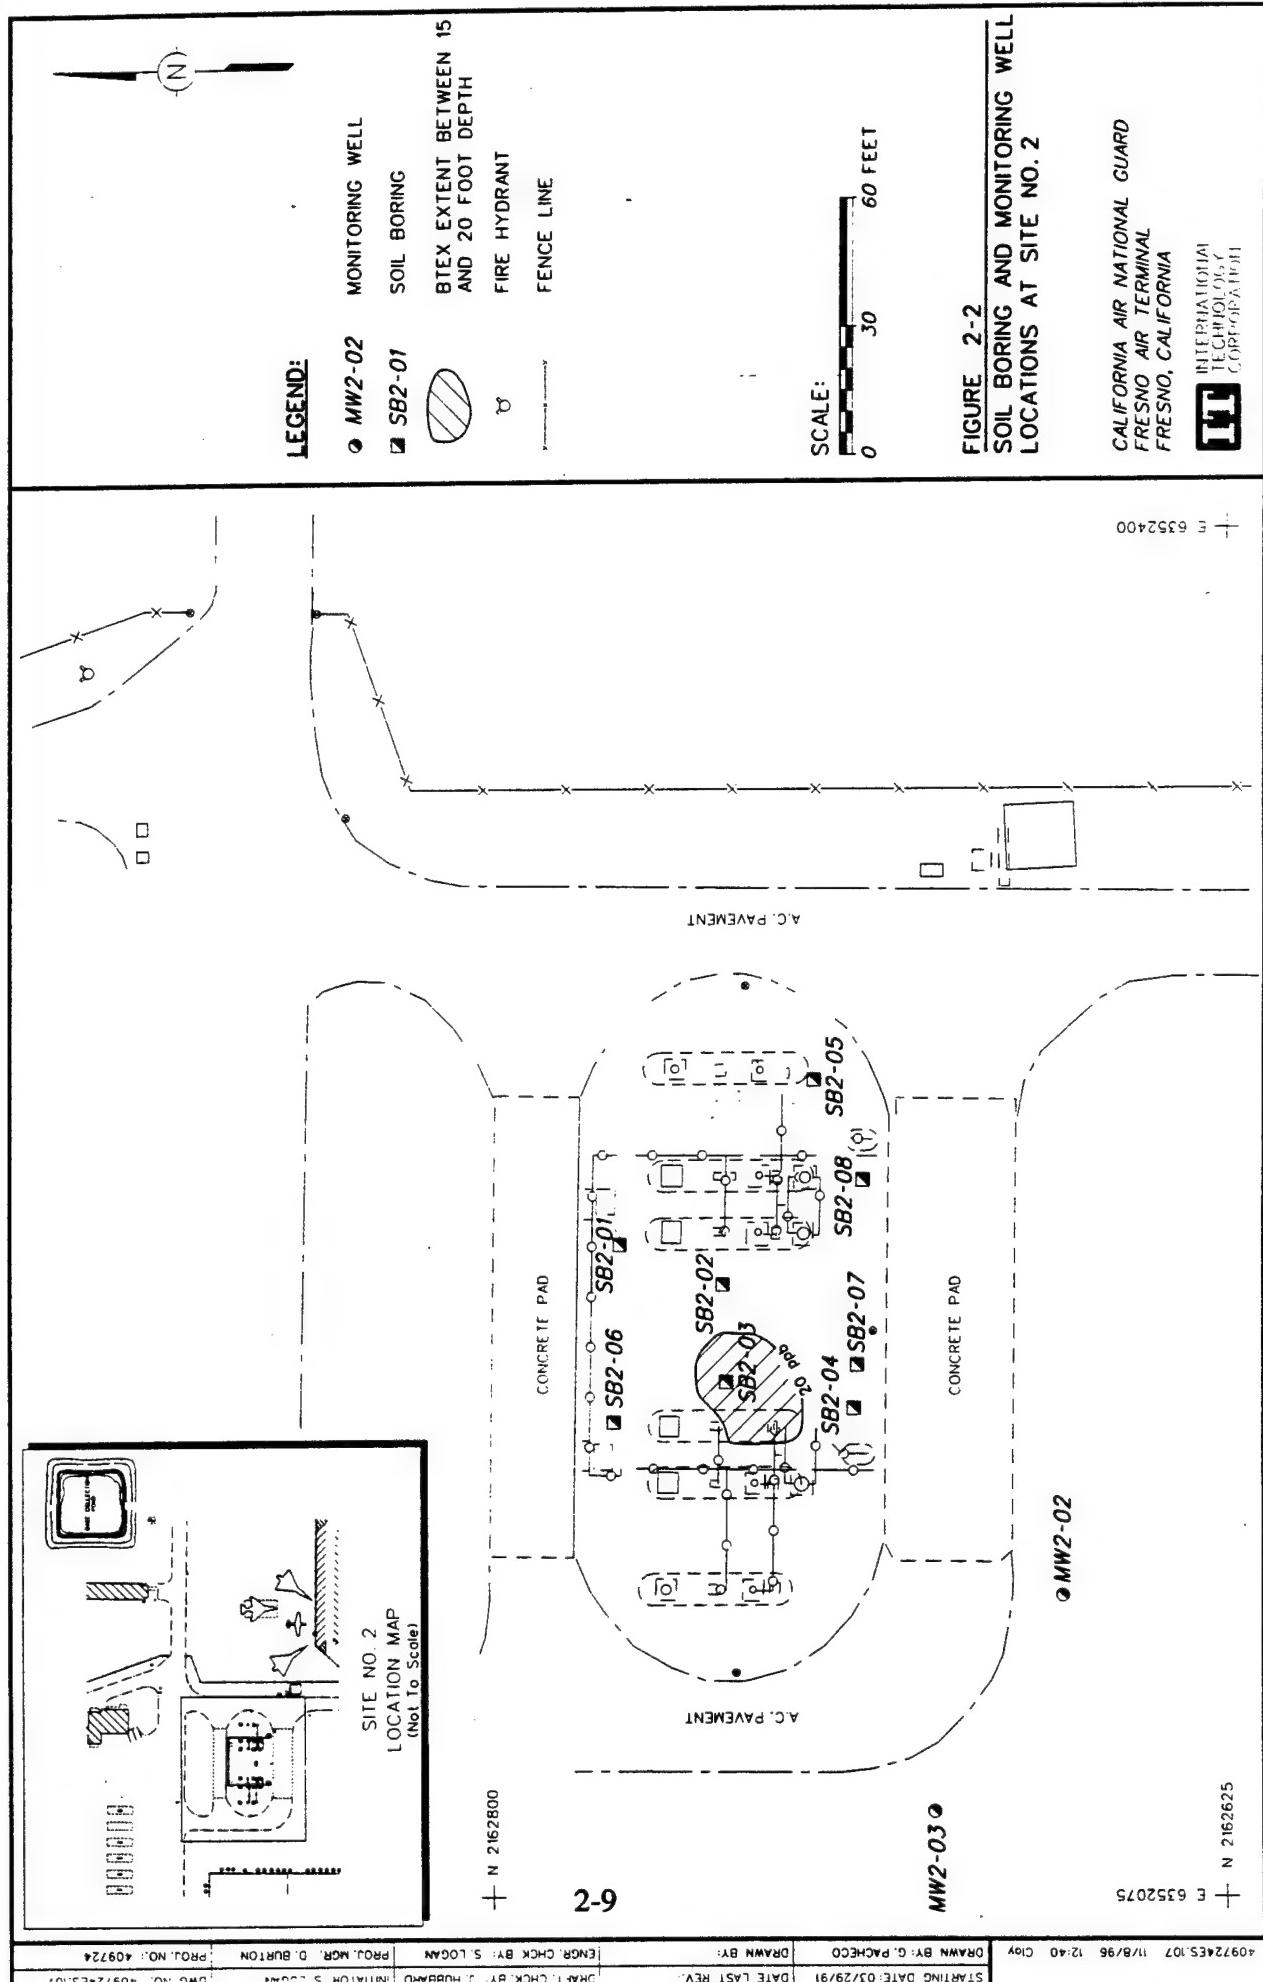
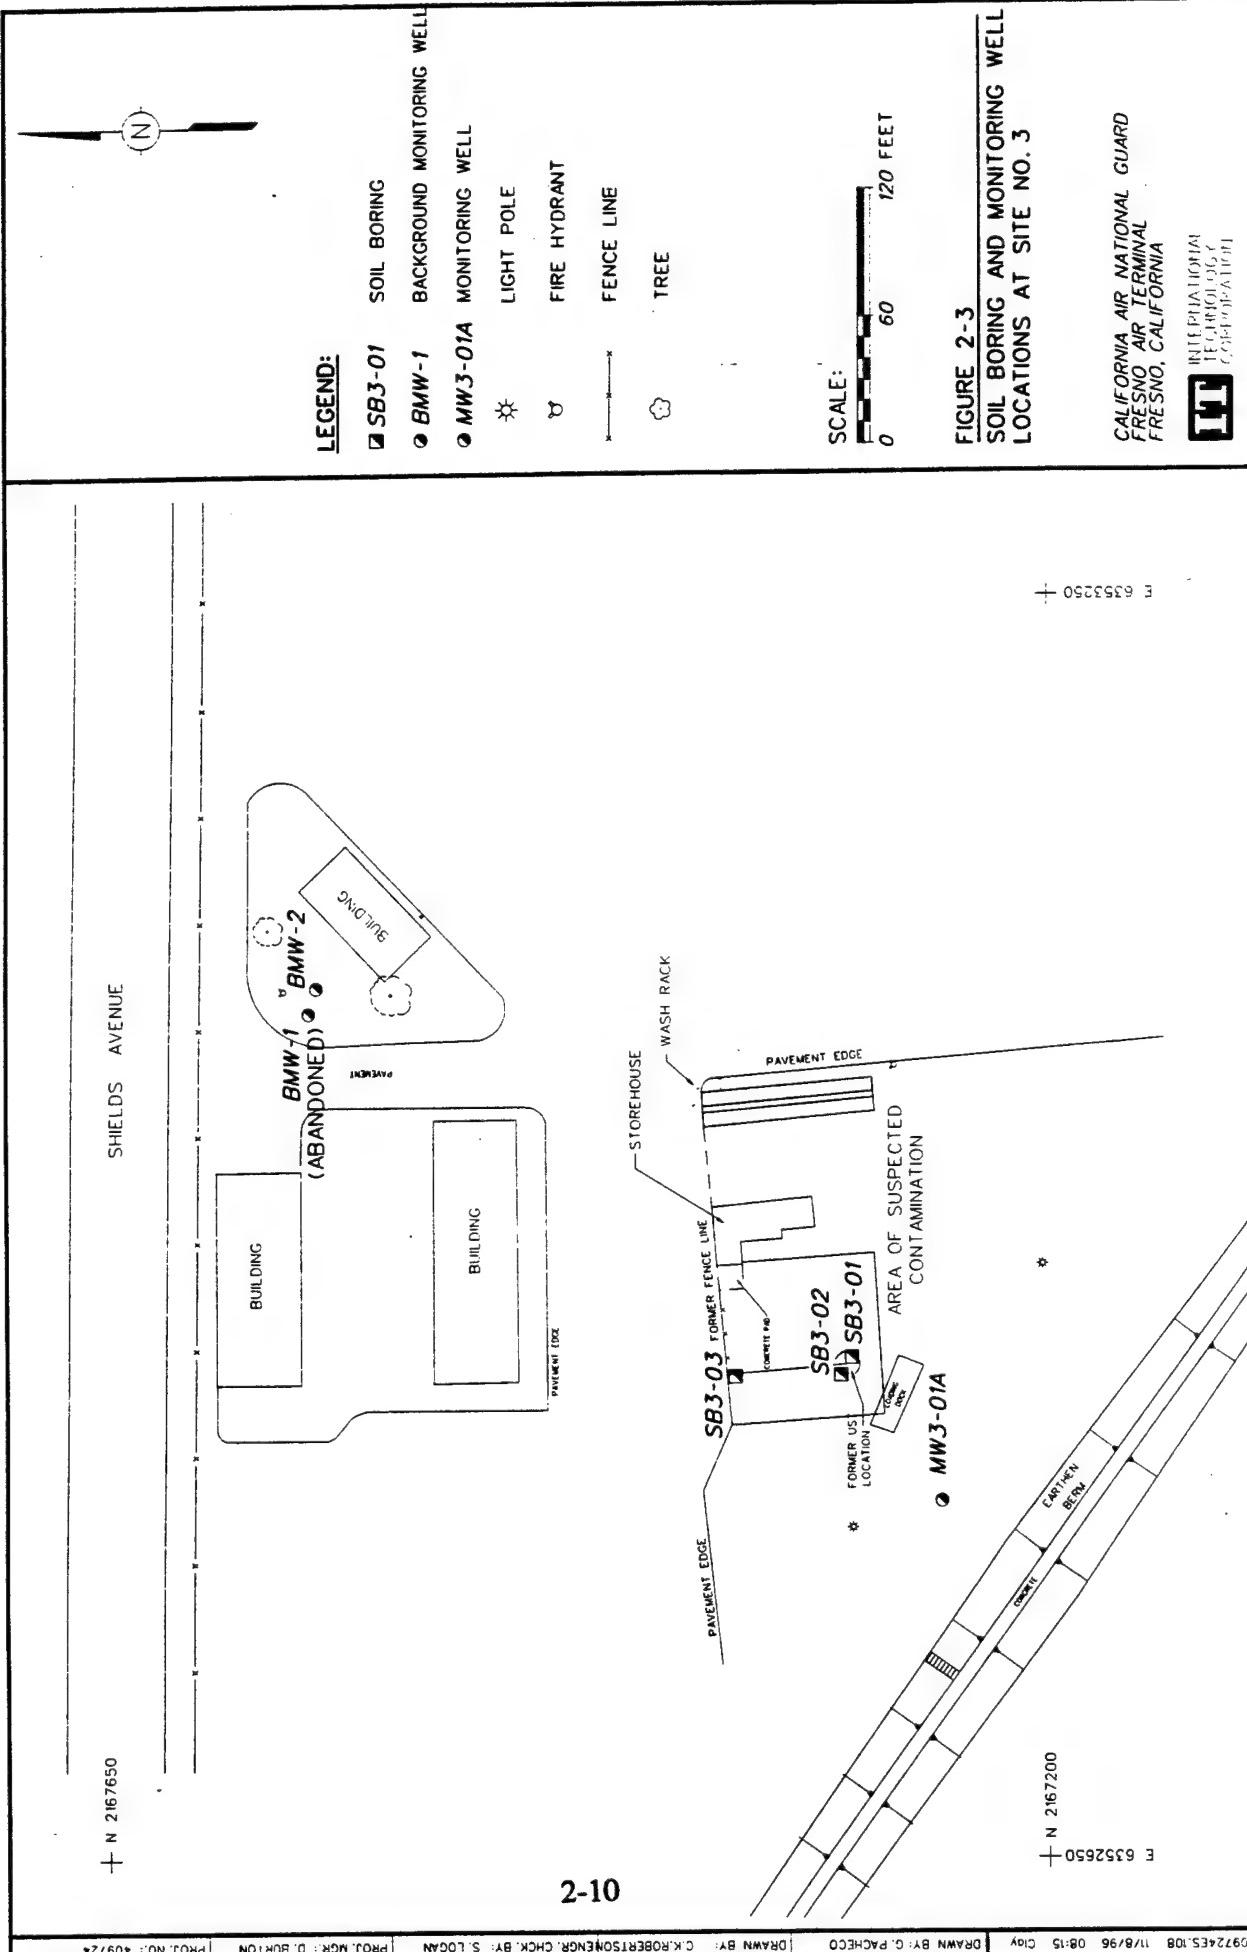
FIGURE 2-3
SOIL BORING AND MONITORING WELL
LOCATIONS AT SITE NO. 3

SI activities at Site 3 comprised collecting 18 SOV samples, drilling and sampling 3 borings, and installing 1 monitoring well (Figure 2-3). Additionally, two background monitoring wells were installed upgradient of Site 3 and served as both site- and Base-specific background monitoring wells. No significant findings were discovered with the SOV survey. No source area for

An absence of detections in groundwater samples verified that groundwater has not been impacted by past handling and disposal activities at Site 3.

Recommendations from the SI included continuing periodic groundwater sampling to monitor groundwater quality at the site. A baseline risk assessment was also recommended to quantify exposure risks. However, with the development of risk-based PRGs, it was agreed by DTSC that a baseline risk assessment was no longer required for sites that were not carried forward to a RI. Rather, soil contaminant concentrations will be compared to PRGs in Section 4.2 to determine if further action is warranted.
